Manhole Inspection Summary

Manhole # S39W1_009MH

Insp Date: **4/30/08 2:16 PM**

Location Address: **405 E. Patapsco Ave.**

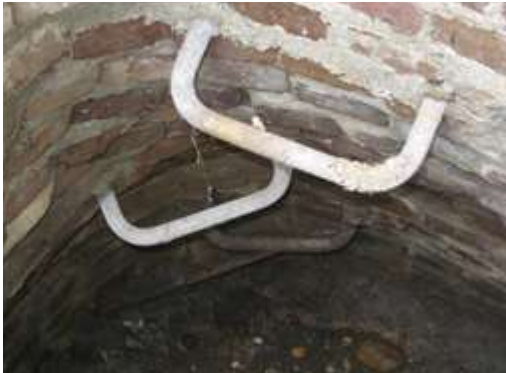
Steps

Count: **3** Missing: **0** ☒ **Corroded**

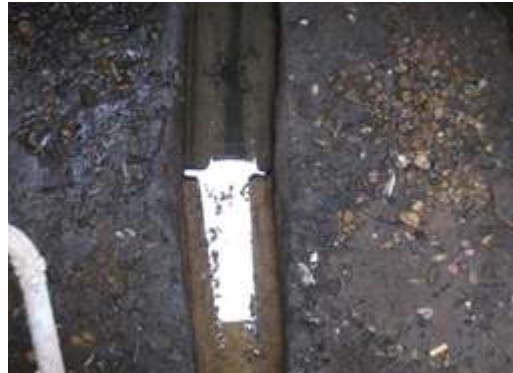
Defect 2

Condition: ☐ Sound ☐ Cracked ☐ Root Intrusion ☐ Deteriorated ☐ Leaks ☒ **Debris**

Mud and Debris on bench

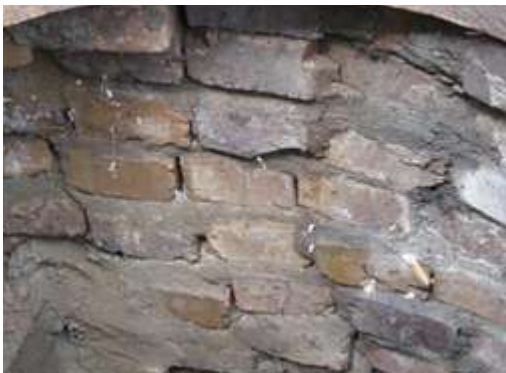
Defect 1

Condition: ☐ Sound ☒ **Cracked** ☐ Root Intrusion ☐ Loose Brick ☐ Deteriorated

Infiltration: ☐ None ☐ Joint ☒ **Cracks** ☐ Mortar ☐ Roots ☒ **Wall**

Cracked Wall

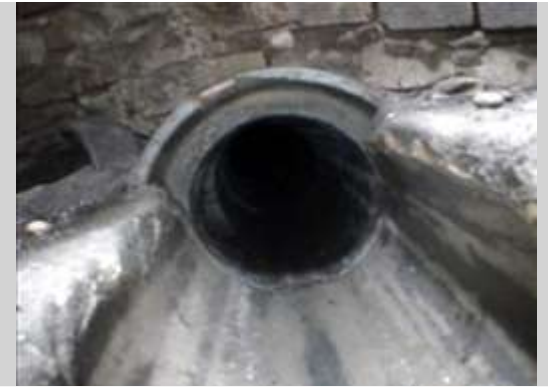
12 O'Clock Outflow

Pipe Height: **8.4** (in.) Rod and Bar (Angled)
Pipe Material: **Clay** ☐ Pipe Lined
Invert Depth: **6.70** (ft.) Flow Characteristics: **None**
Deposits: ☒ None ☐ Mud ☐ Sludge ☐ Debris ☐ Grease
Silt Depth: (in.) Deposits Extent:
Infiltration: **None** Pipe Seal Cond: **Sound**

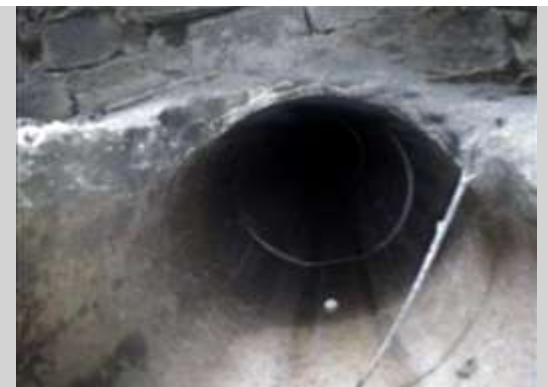
6 O'Clock Inflow

Pipe Height: **8.4** (in.) Rod and Bar (Angled)
Pipe Material: **Clay** ☐ Pipe Lined
Invert Depth: **6.26** (ft.) Flow Characteristics: **None**
Deposits: ☒ None ☐ Mud ☐ Sludge ☐ Debris ☐ Grease
Silt Depth: (in.) Deposits Extent:
Infiltration: **None** Pipe Seal Cond: **Sound**
